SCBA CYLINDER INSPECTION FIBERGLASS COMPOSITE CYLINDERS

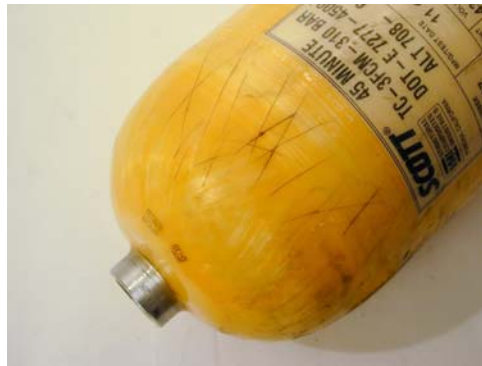
Level 1 damage or defects are identified by scratches or damage to the outer coating of the cylinder. The cylinder may also exhibit a slight discoloration of the outer coating. This level defect does not require the cylinder to be removed from service. Slight discoloration of the outer coating also does not require removal of the cylinder from service unless the labeling of the cylinder has also turned black or brown, or the labels are slightly charred. (Reference figure 2) Areas of the cylinder exhibiting Level 1 damage are to be monitored for possible additional damage.

Figure 2
Level 1 Damage/Defect
Scratches in the outer coating of the cylinder

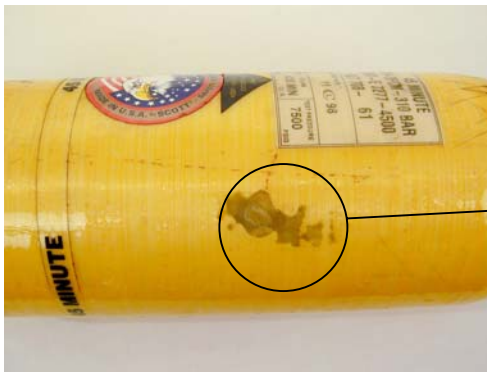
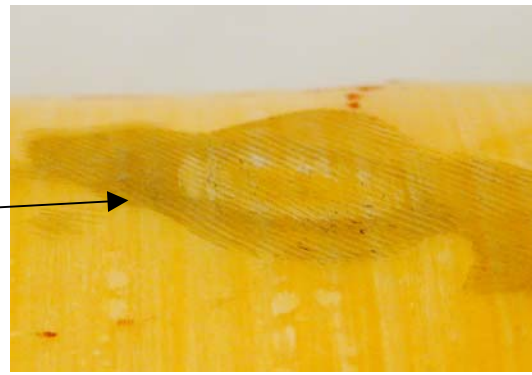
Figure 3
Level 2 Damage/Defect

A Level 2 damage or defect of the cylinder constitutes damage beyond Level 1, affecting the fiberglass composite layer of the cylinder. This damage will expose the fiberglass composite layer and may further exhibit fraying of the fiberglass composite. (Reference figure 3) Cylinders exhibiting Level 2 damage should be removed from service and forwarded to a US Department of Transportation (DOT) authorized hydrostatic testing facility for further inspection and repair.

Level 2 Damage on cylinder Side wall*
(* area darkened for viewing picture)

Magnified View of Level 2 Damage

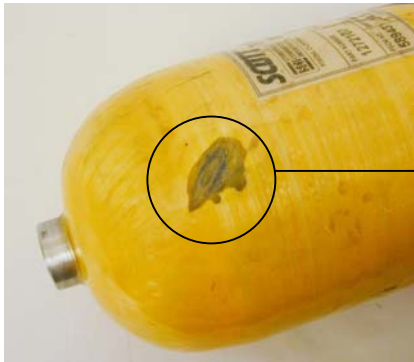
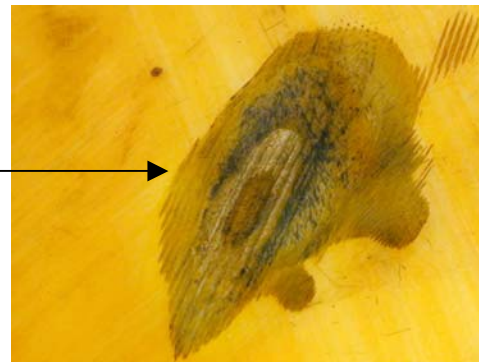
Figure 4
Level 3 Damage/Defect

Level 3 damage to the cylinder will exhibit a deep cut or abrasion of the outer gel coat and fiberglass layer. Level 3 damage can also be identified as severe discoloration of the cylinder with the labeling becoming bubbled, and charred from exposure to high heat. (Reference figure 4) Cylinders exhibiting Level 3 damage should be depressurized of air and removed from service.

Level 3 Damage on cylinder crown*
(* area darkened for viewing picture)

Magnified view of Level 3 Damage
